**WELL ASSESSMENT REPORT
CEDAR CHEMICAL COMPANY
WEST HELENA, ARKANSAS**

Revision: 0

August 6, 2007

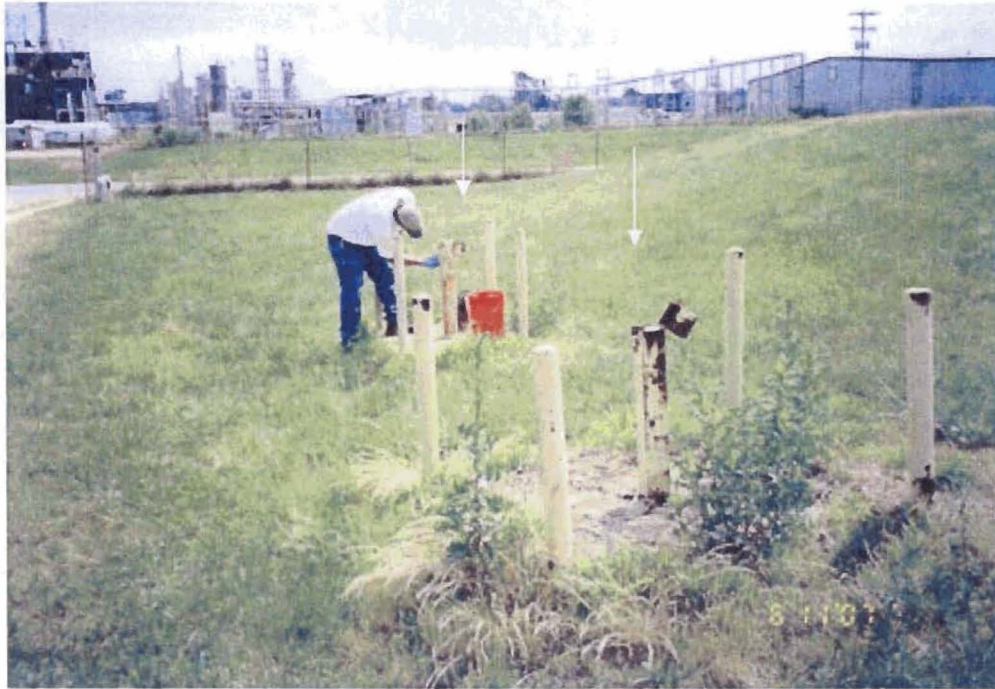
Photo 1: View of wells 1MW-1 (background) and 1MW-7 (foreground).

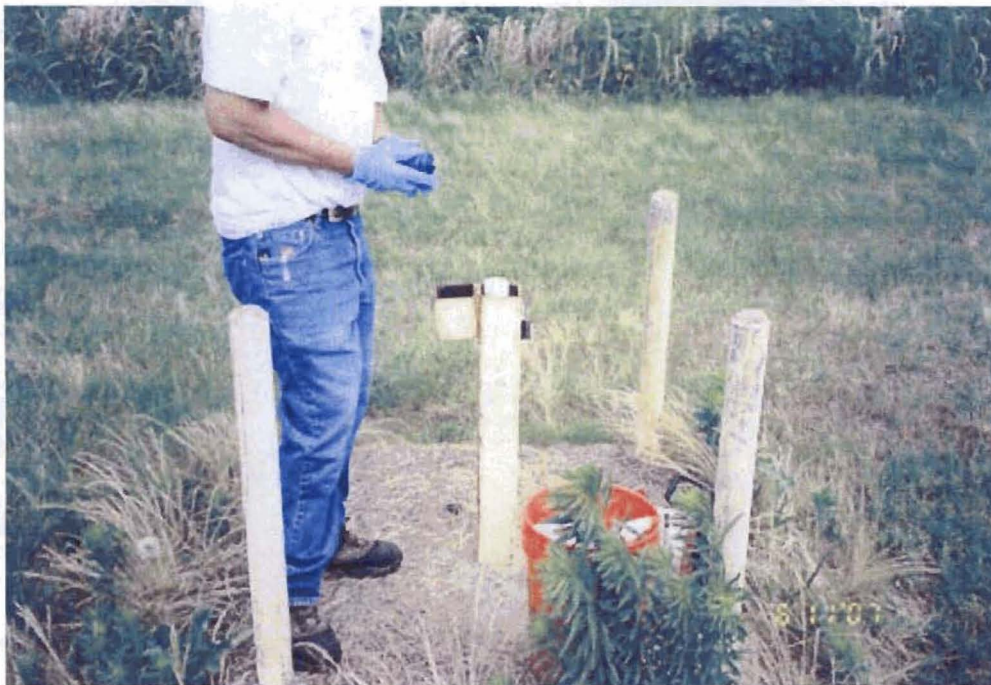
Photo 2: View of well 1MW-2.

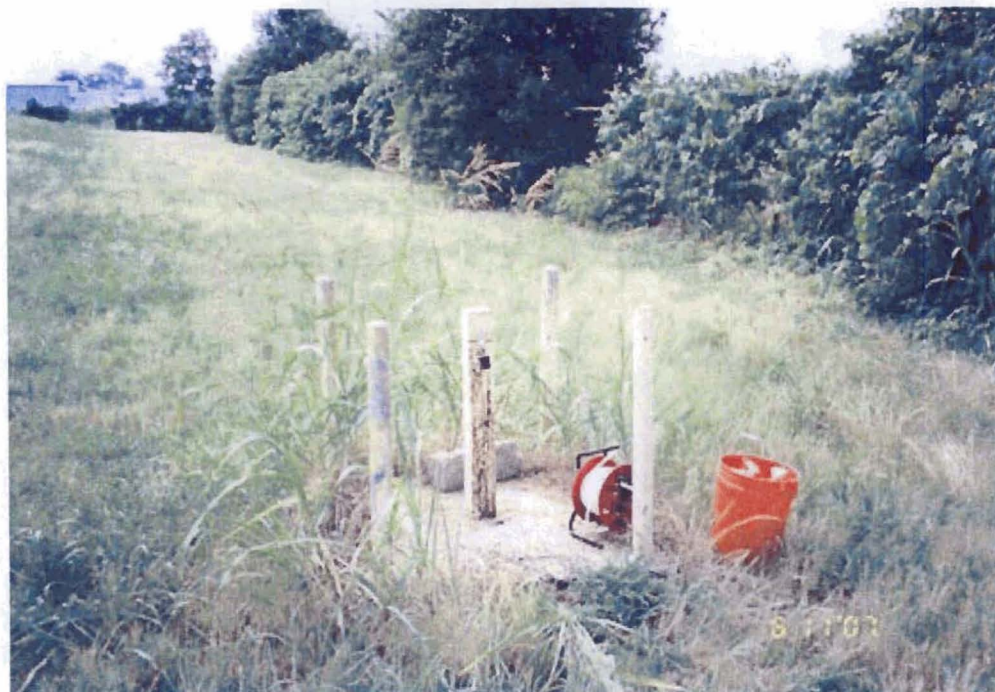
Photo 3: View of well 1MW-3.

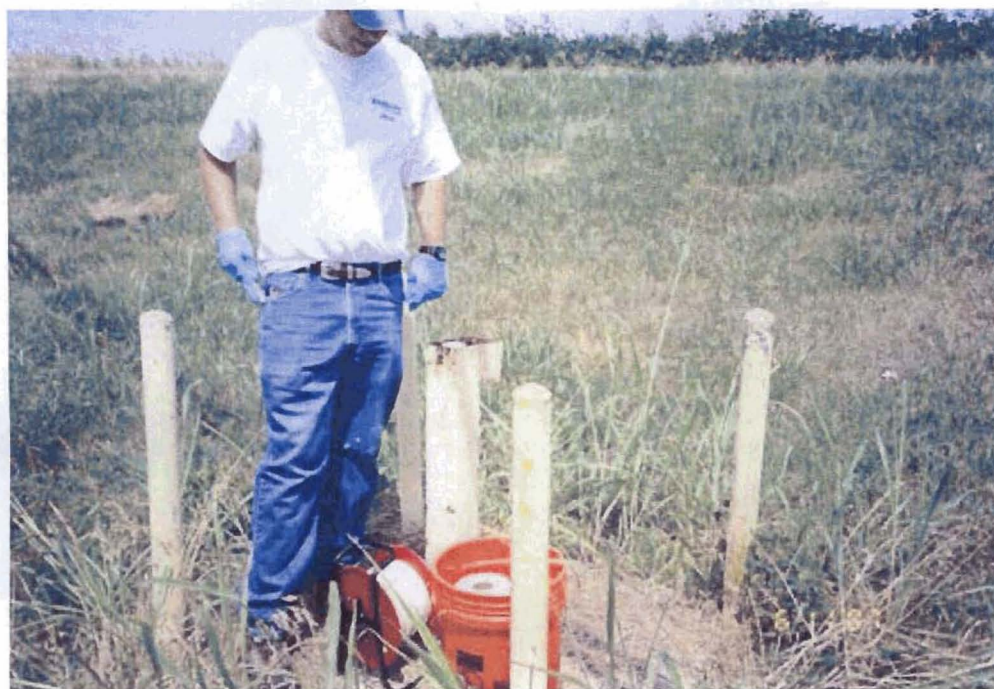
Photo 4: View of well 1MW-5.

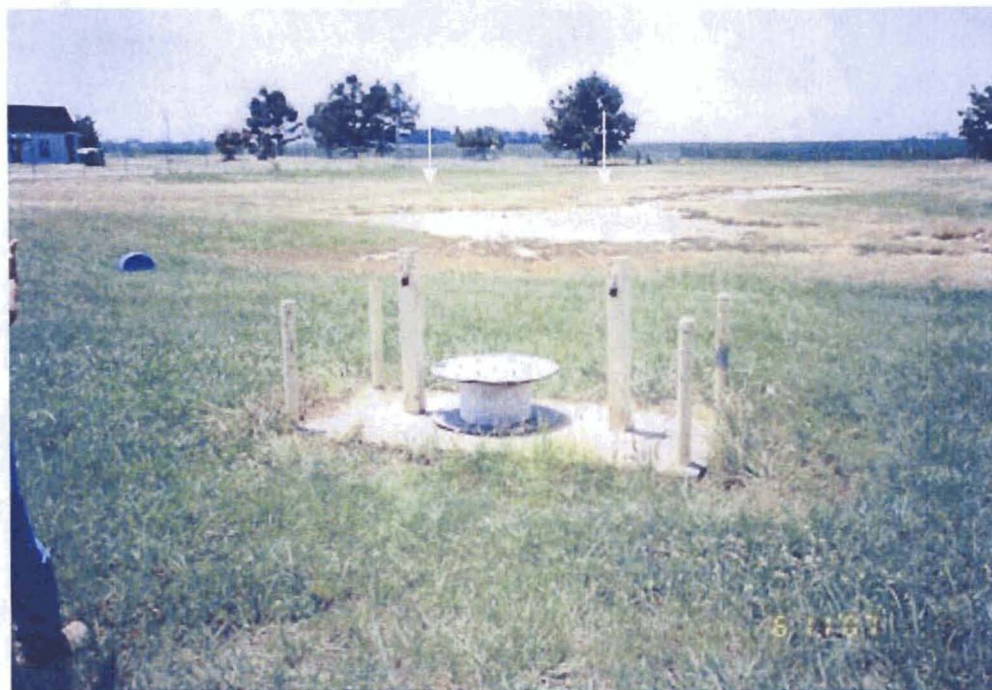
Photo 5: View of wells 2MW-4 (left) and 2MW-1 (right).

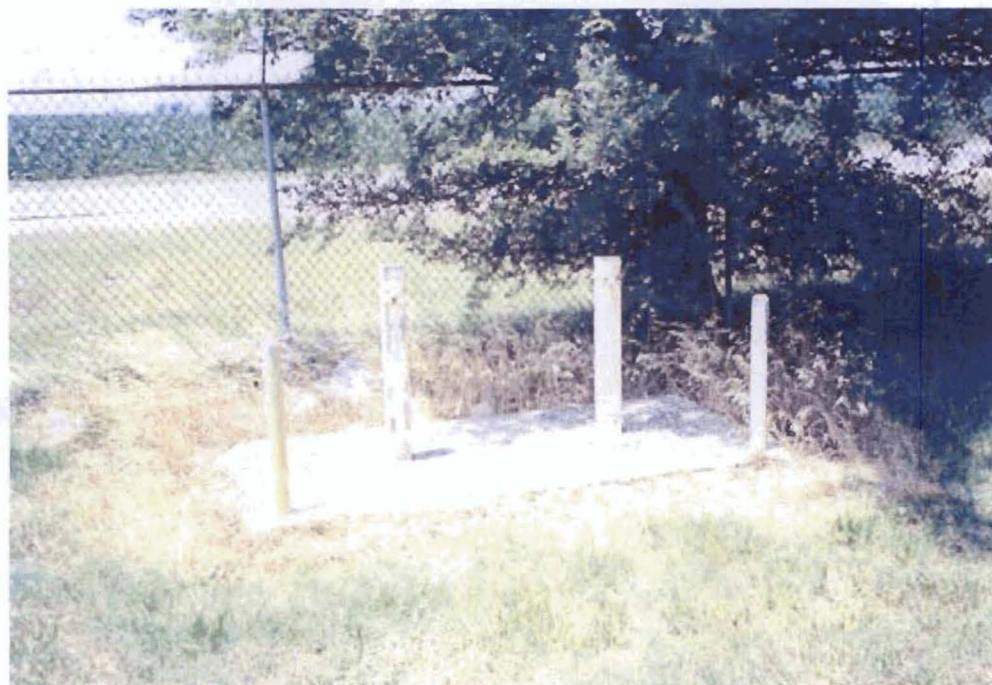
Photo 6: View of wells 2MW-5 (left) and 2MW-2 (right).

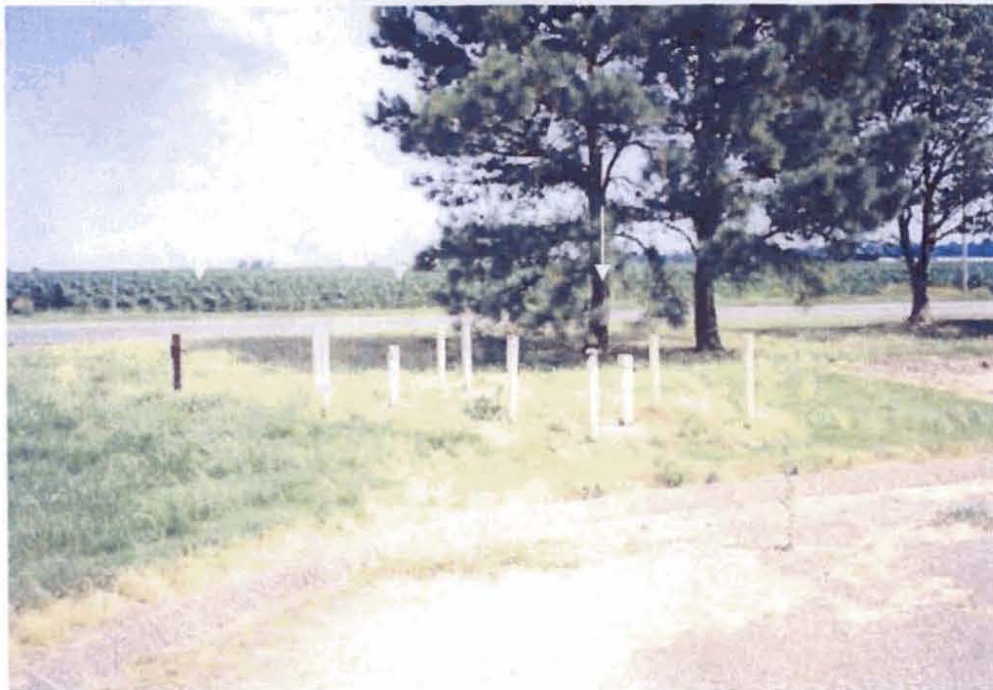
Photo 7: View an unidentified well (far left) and wells 2MW-6 (middle) and 2MW-7 (right).

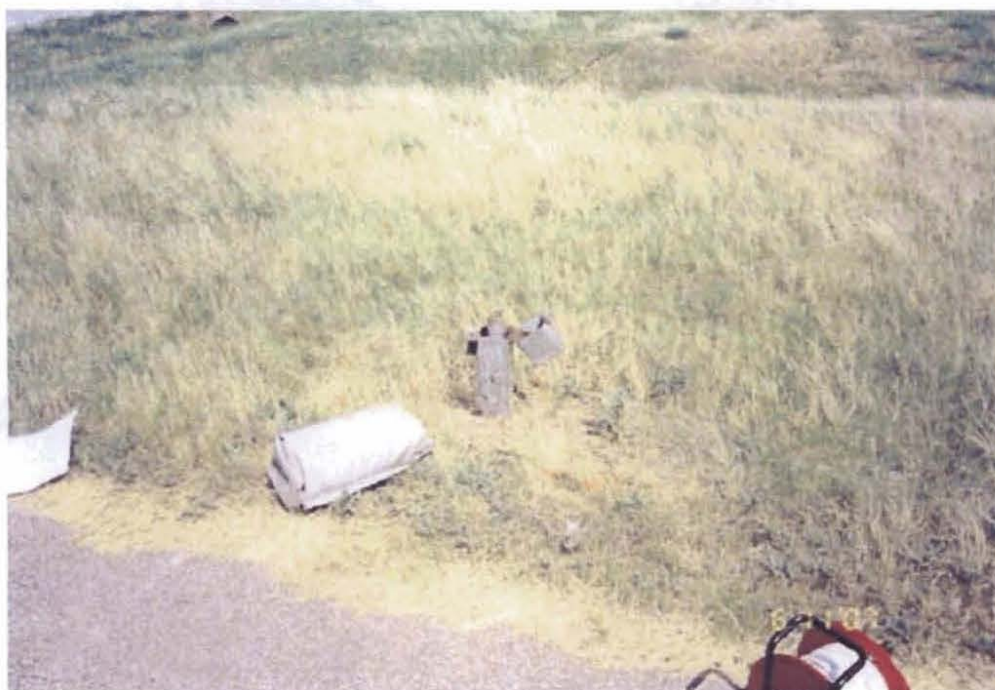
Photo 8: View of well EMW-1.

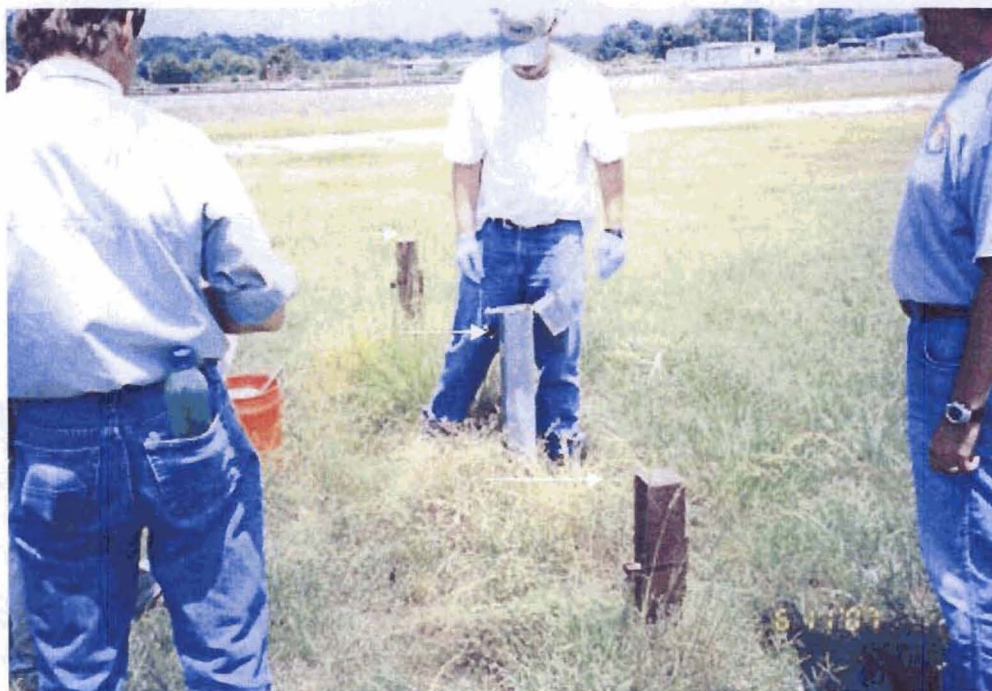
Photo 9: View of two unidentified wells (foreground and background) and well EMW-2 (middle).

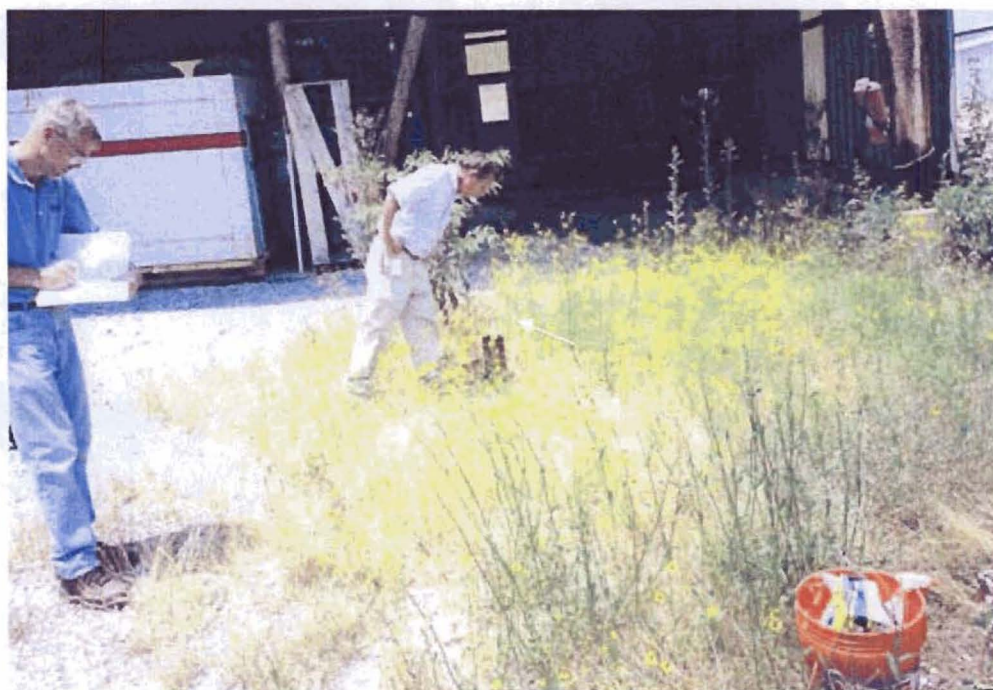
Photo 10: View of well EMW-3.

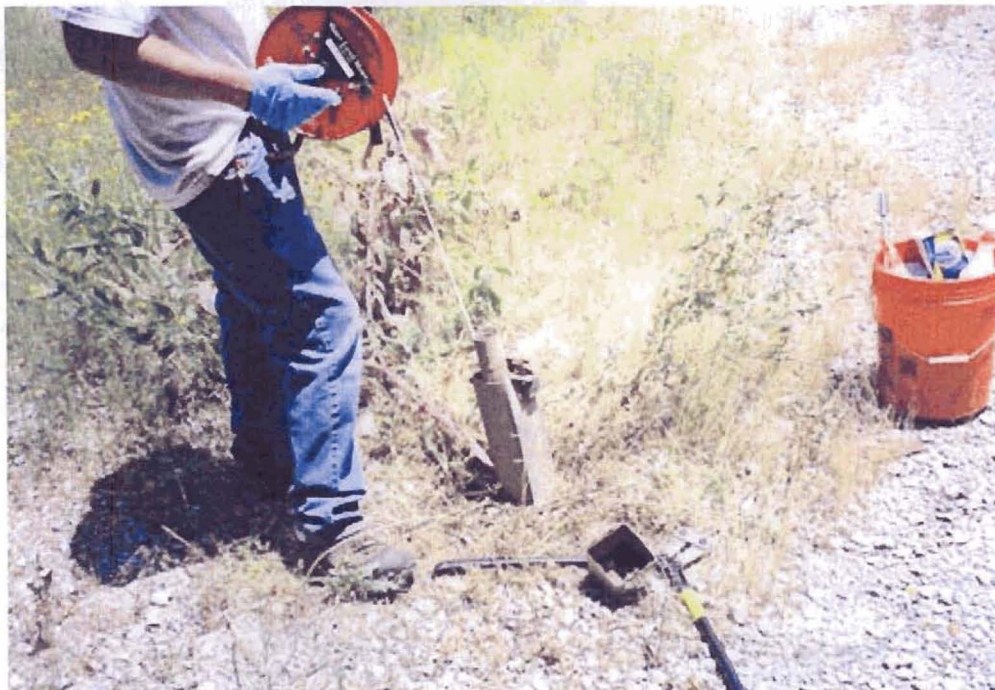
Photo 11: Close-up view well EMW-3.

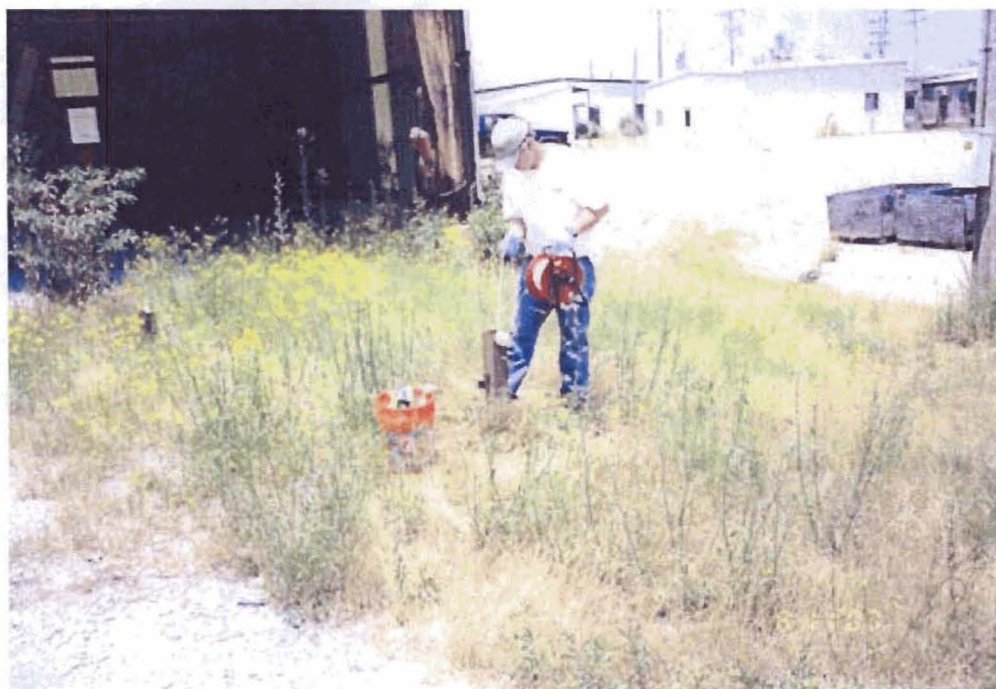
Photo 12: View of an unidentified well near EMW-3.

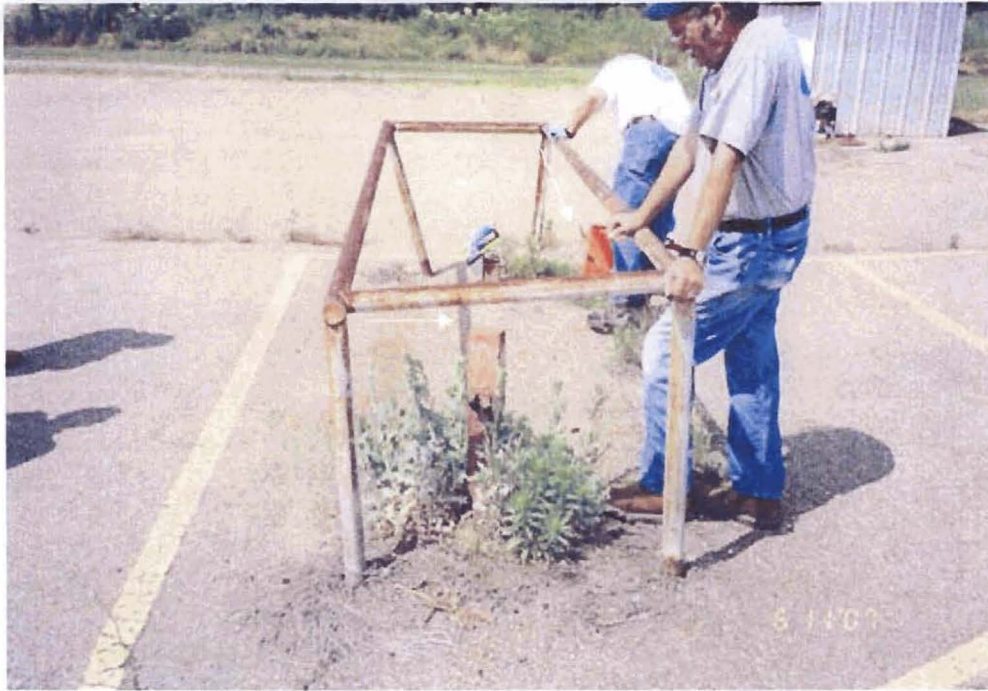
Photo 13: View well EMW-4 (background) and an unidentified well (EMW-4b) located north of EMW-4 (foreground).

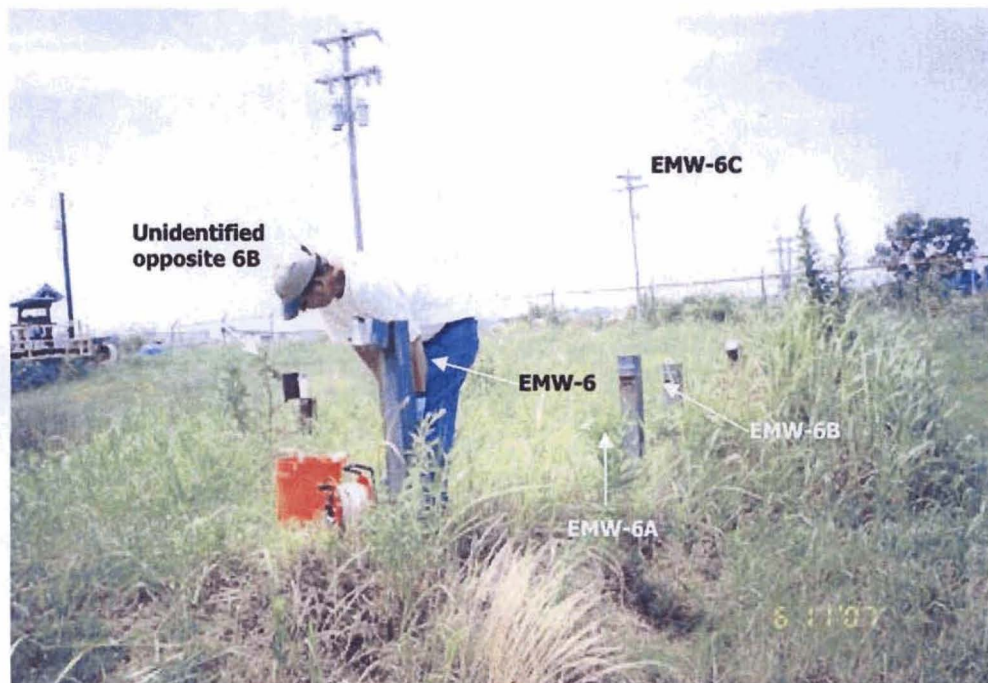
Photo 14: View wells EMW-6, EMW-6A, EMW-6B, EMW-6C, and an unidentified well.

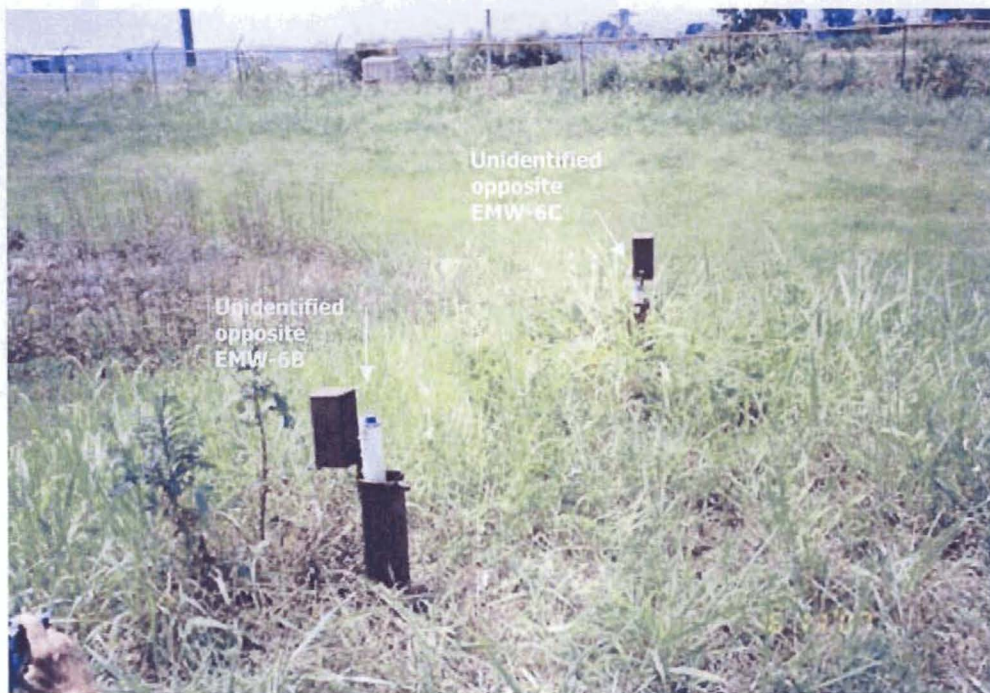
Photo 15: View of an unidentified well opposite EMW-6B and one opposite EMW-6C.

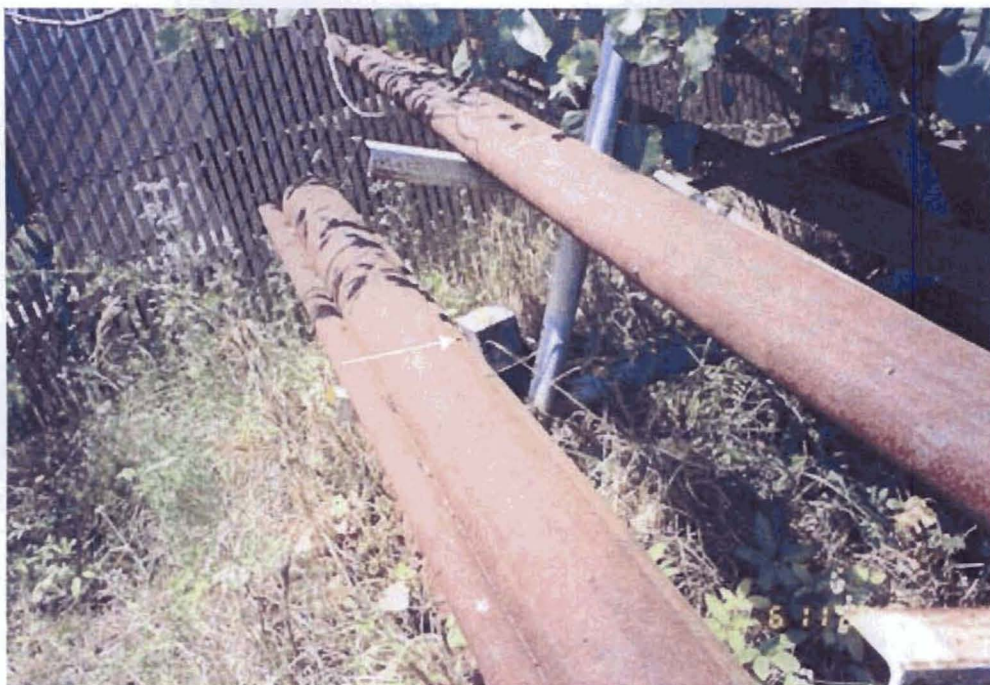
Photo 16: View of well EMW-7.

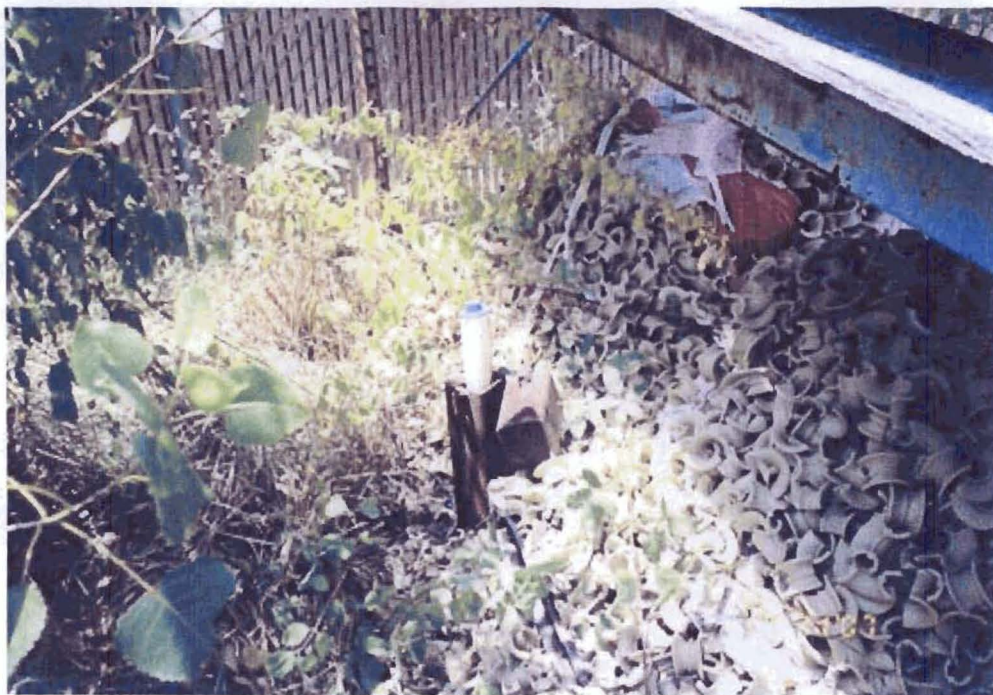
Photo 17: View of unidentified well opposite EMW-7.

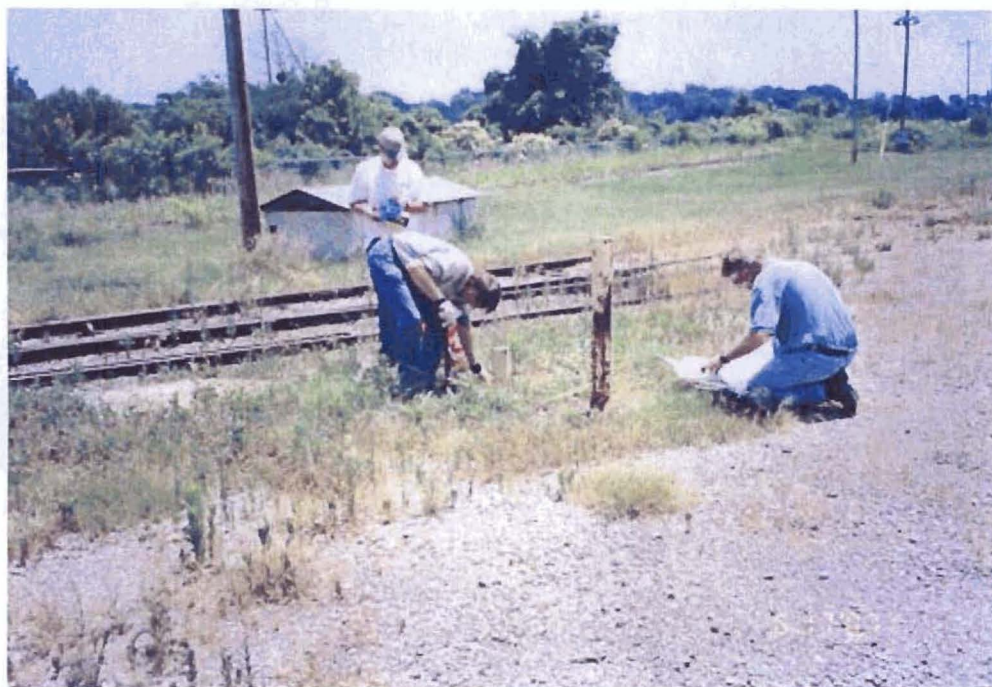
Photo 18: View of unidentified well northeast of Unit 5 at railroad spur.

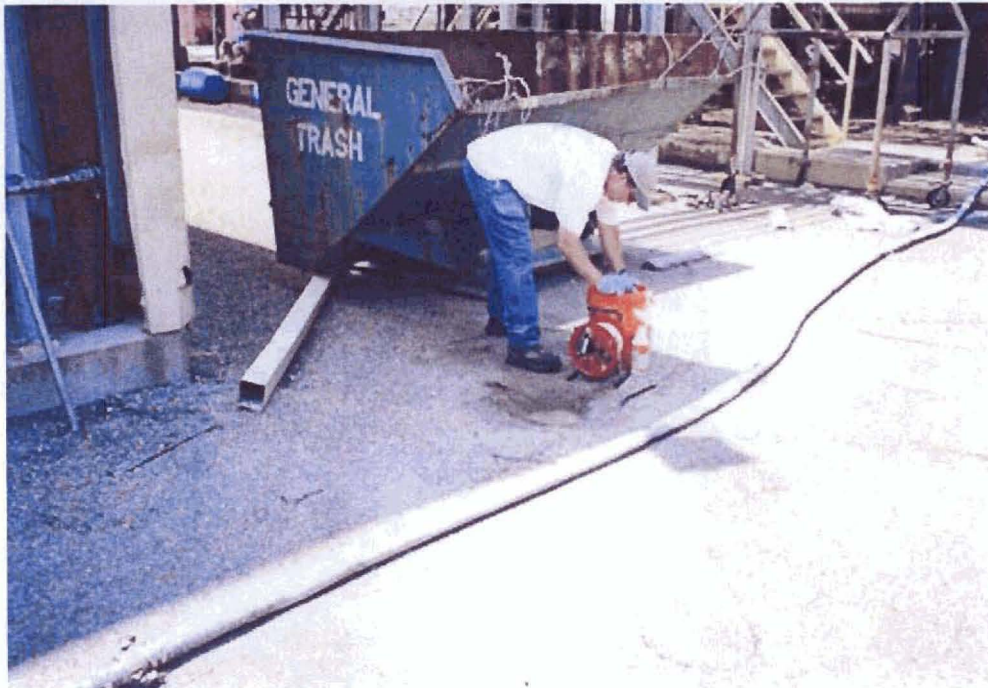
Photo 19: View of well 4MW-1.

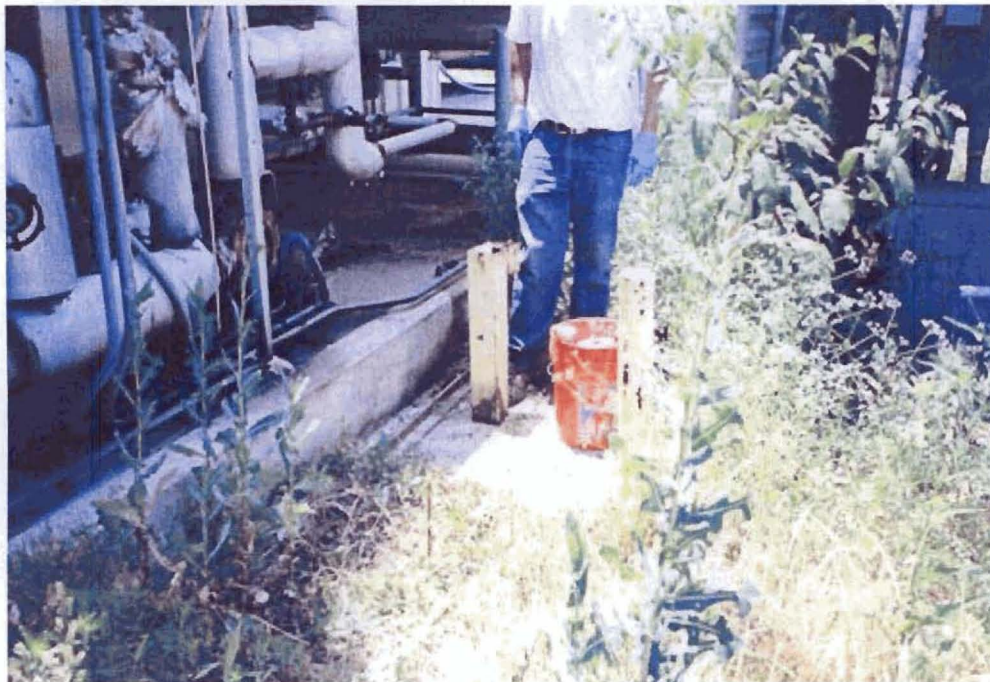
Photo 20: View of well 4MW-3.

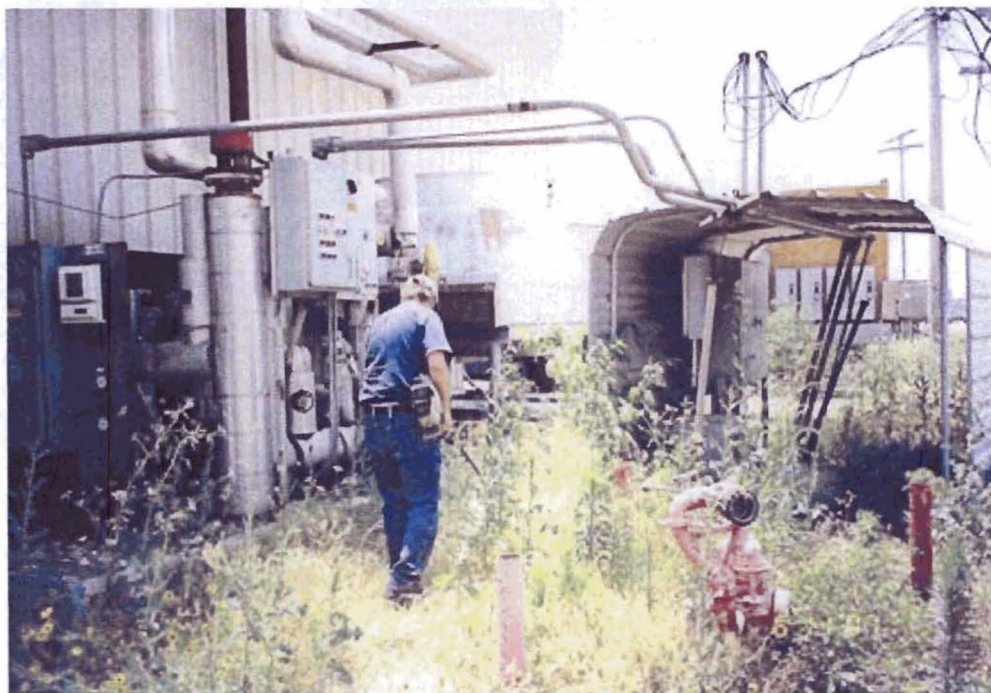
Photo 21: Clearing brush around well 4MW-3.

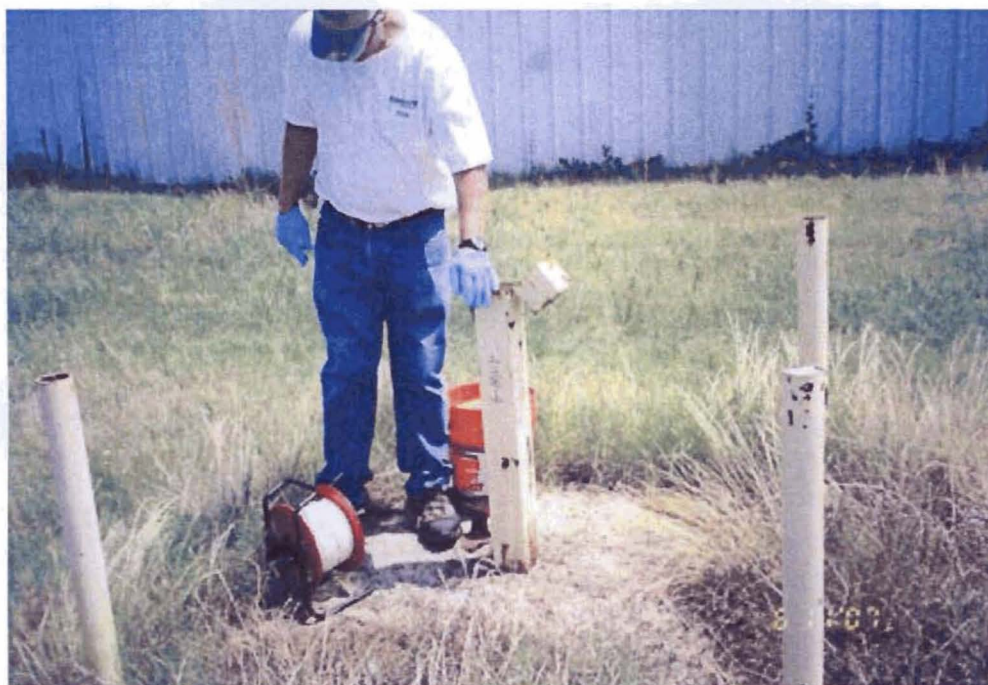
Photo 22: View of well 4MW-4.

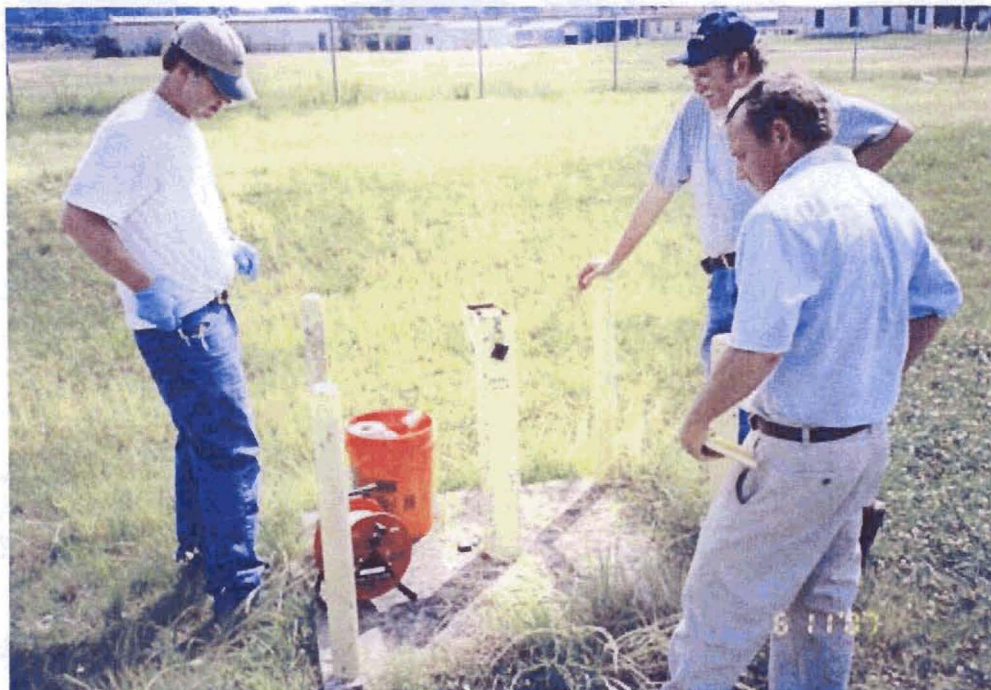
Photo 23: View of well CED2-MW3.

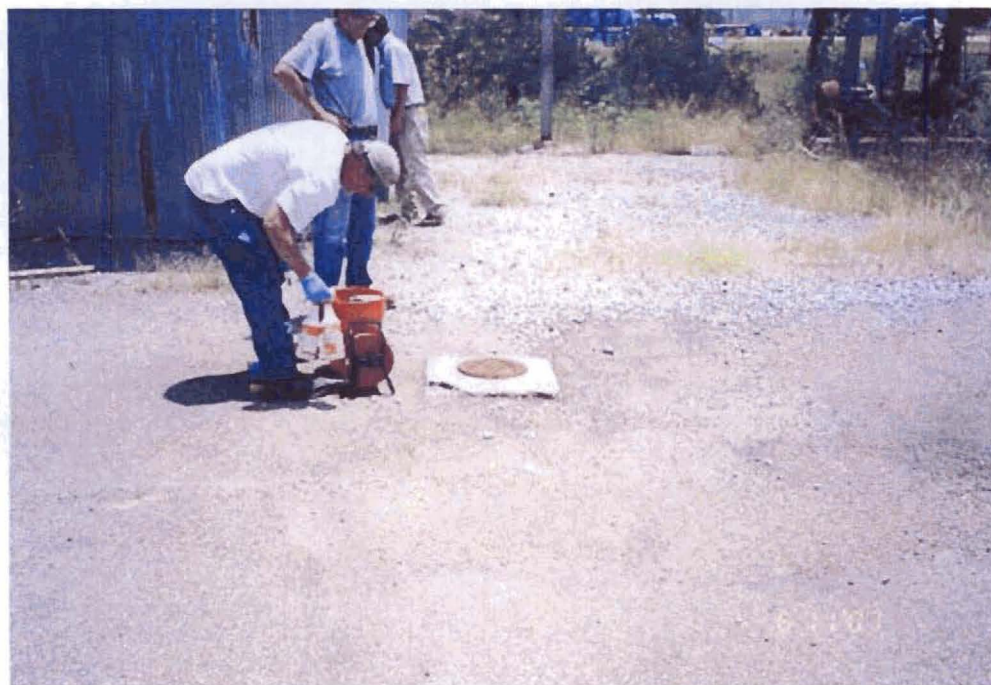
Photo 24: View of well 9MW-1.
